DEVELOPMENT OF REPAIR PROCESSES  
AND SOURCES FOR C/KC-135 AIRCRAFT  
WINDOWS/WINDSHIELDS

RICHARD J. OLSON

BATTELLE  
505 KING AVENUE  
COLUMBUS, OH 43201

SEPTEMBER 1994

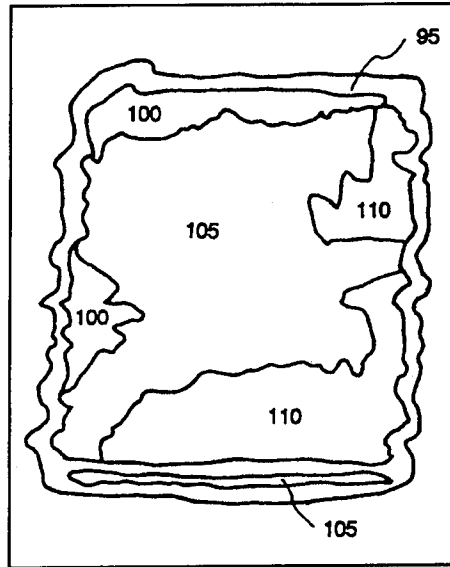
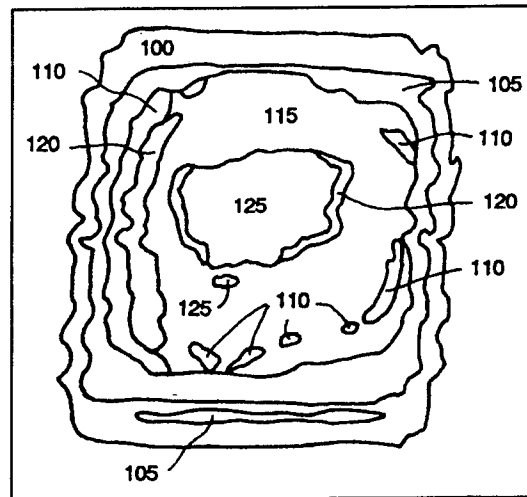
a) Typical (S/N 92-064-HO-471)

b) Most Out-of-the-Ordinary (S/N 92-093-HO-392)

Figure 4.2 C/KC-135 #4 W/WS Thermal Images From the Heater Test

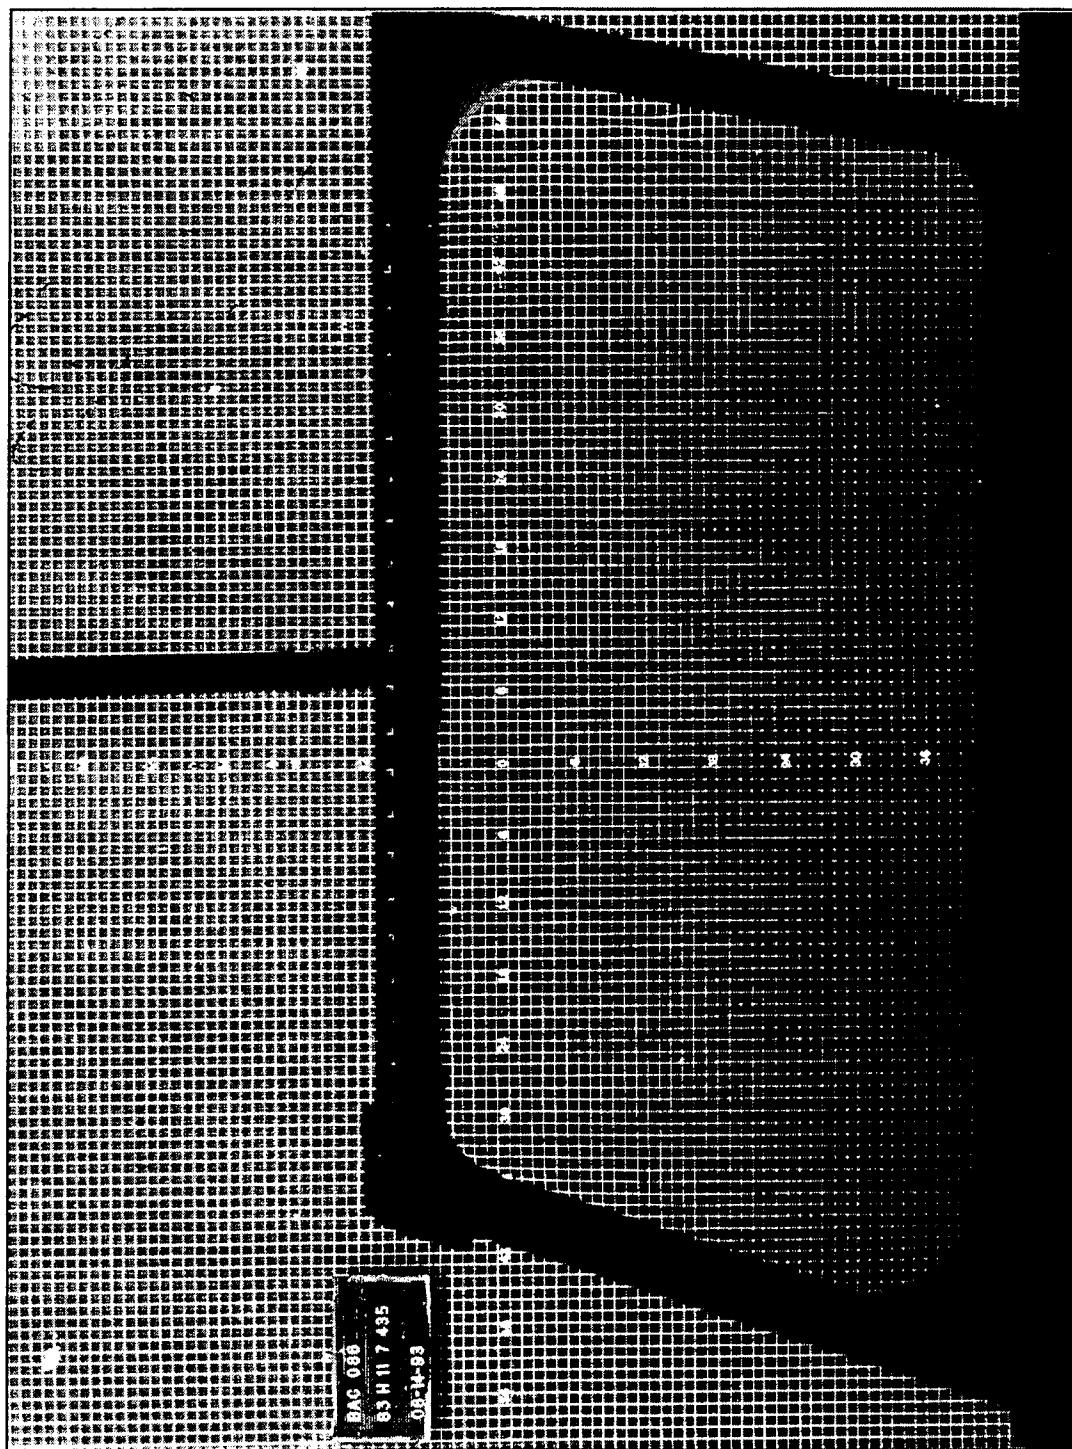
Figure 4.3 Worst Optical Distortion Found in Any C/KC-135 #1 W/WS (S/N 83-H-11-7-432)

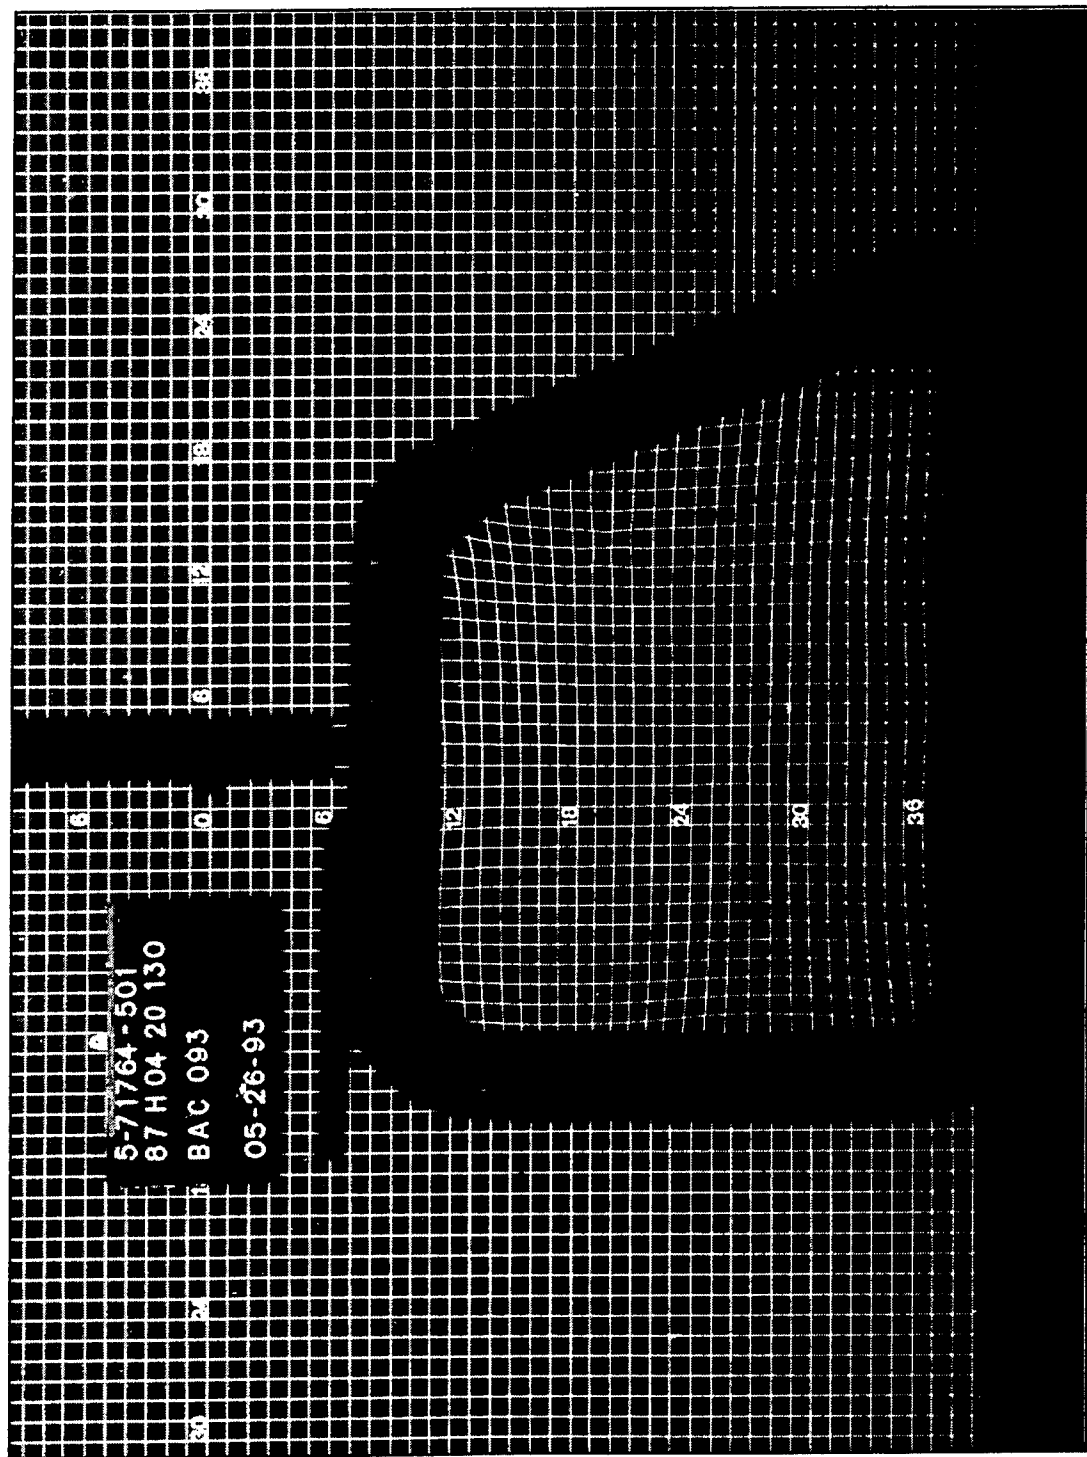
Figure 4.4 Worst Optical Distortion Found in Any C/KC-135 #4 W/WS (S/N 87-H-04-20-130)

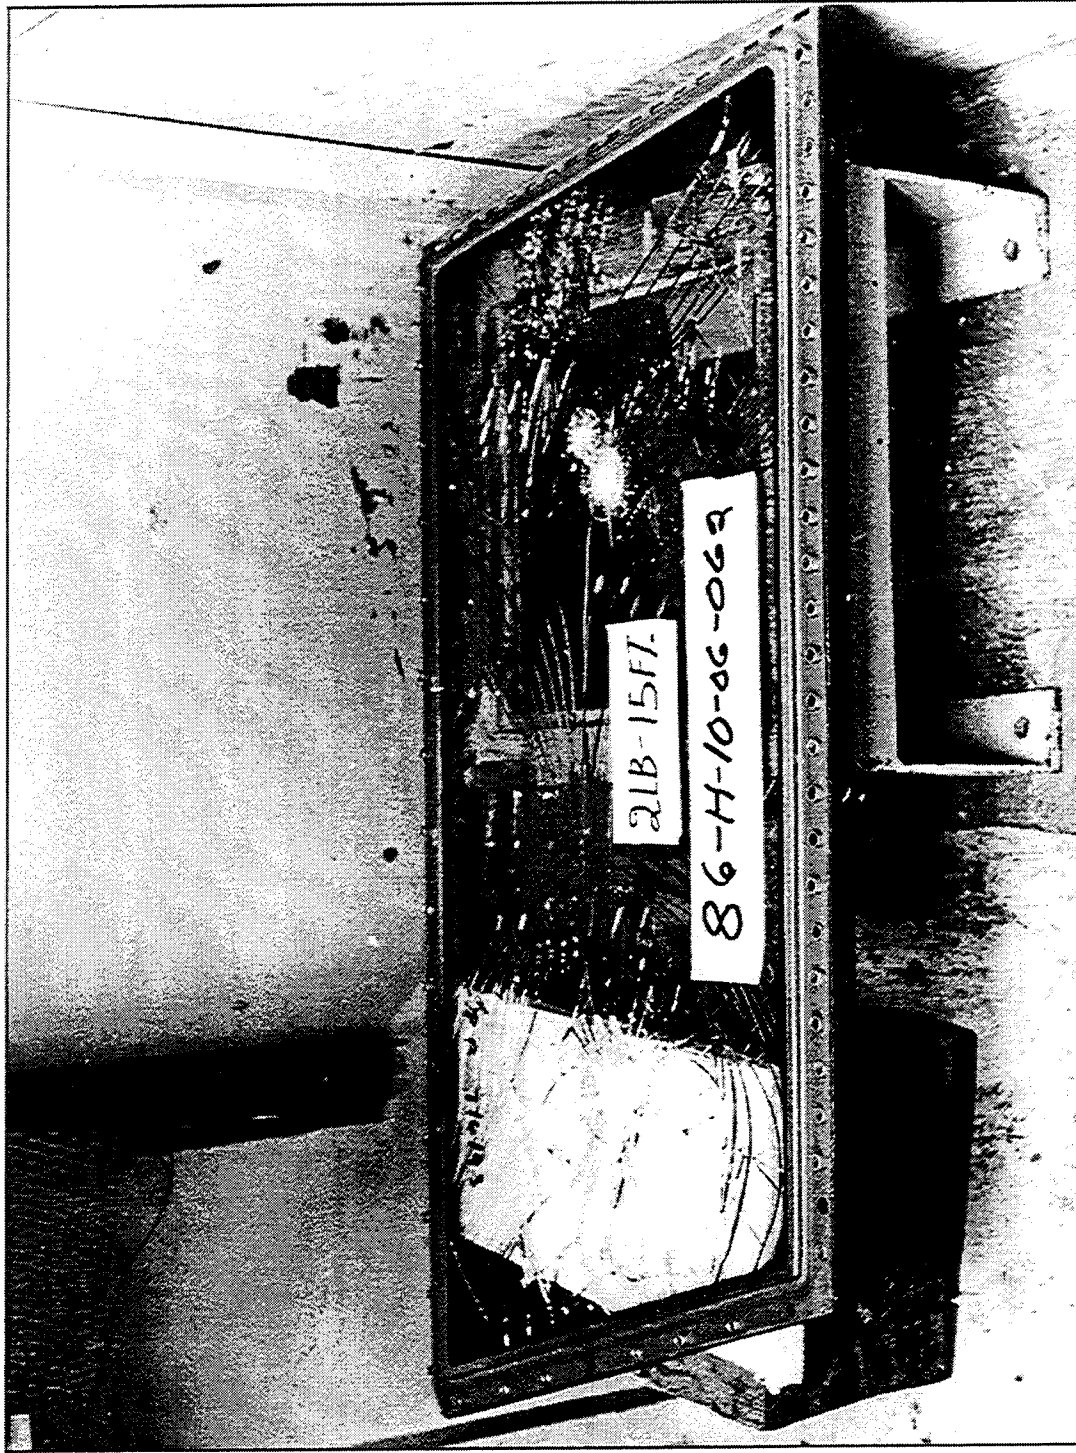
Figure 4.14 #1 W/WS Residual Strength Falling Ball Impact Test Set Up and Consequences of Two Ball Drops  
(New W/WS, S/N 86-H-10-06-062)

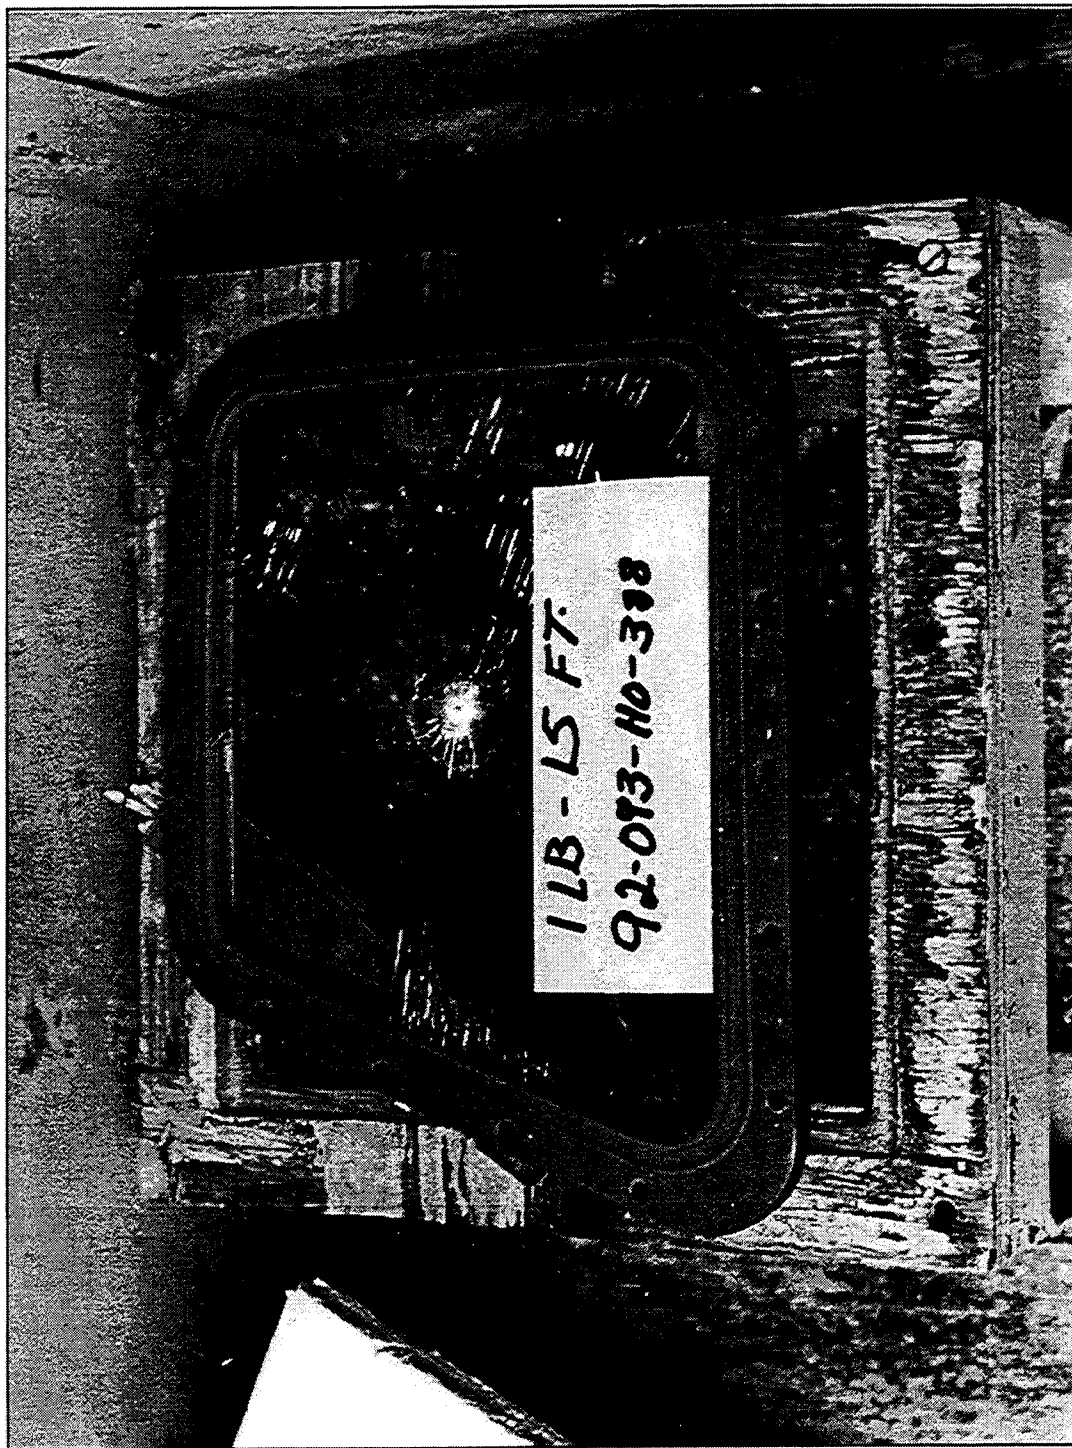
Figure 4.17 #4 W/WS Residual Strength Falling Ball Impact Test Showing Test Set Up and Test Result  
(New W/WS, S/N 92-093-HO-388)

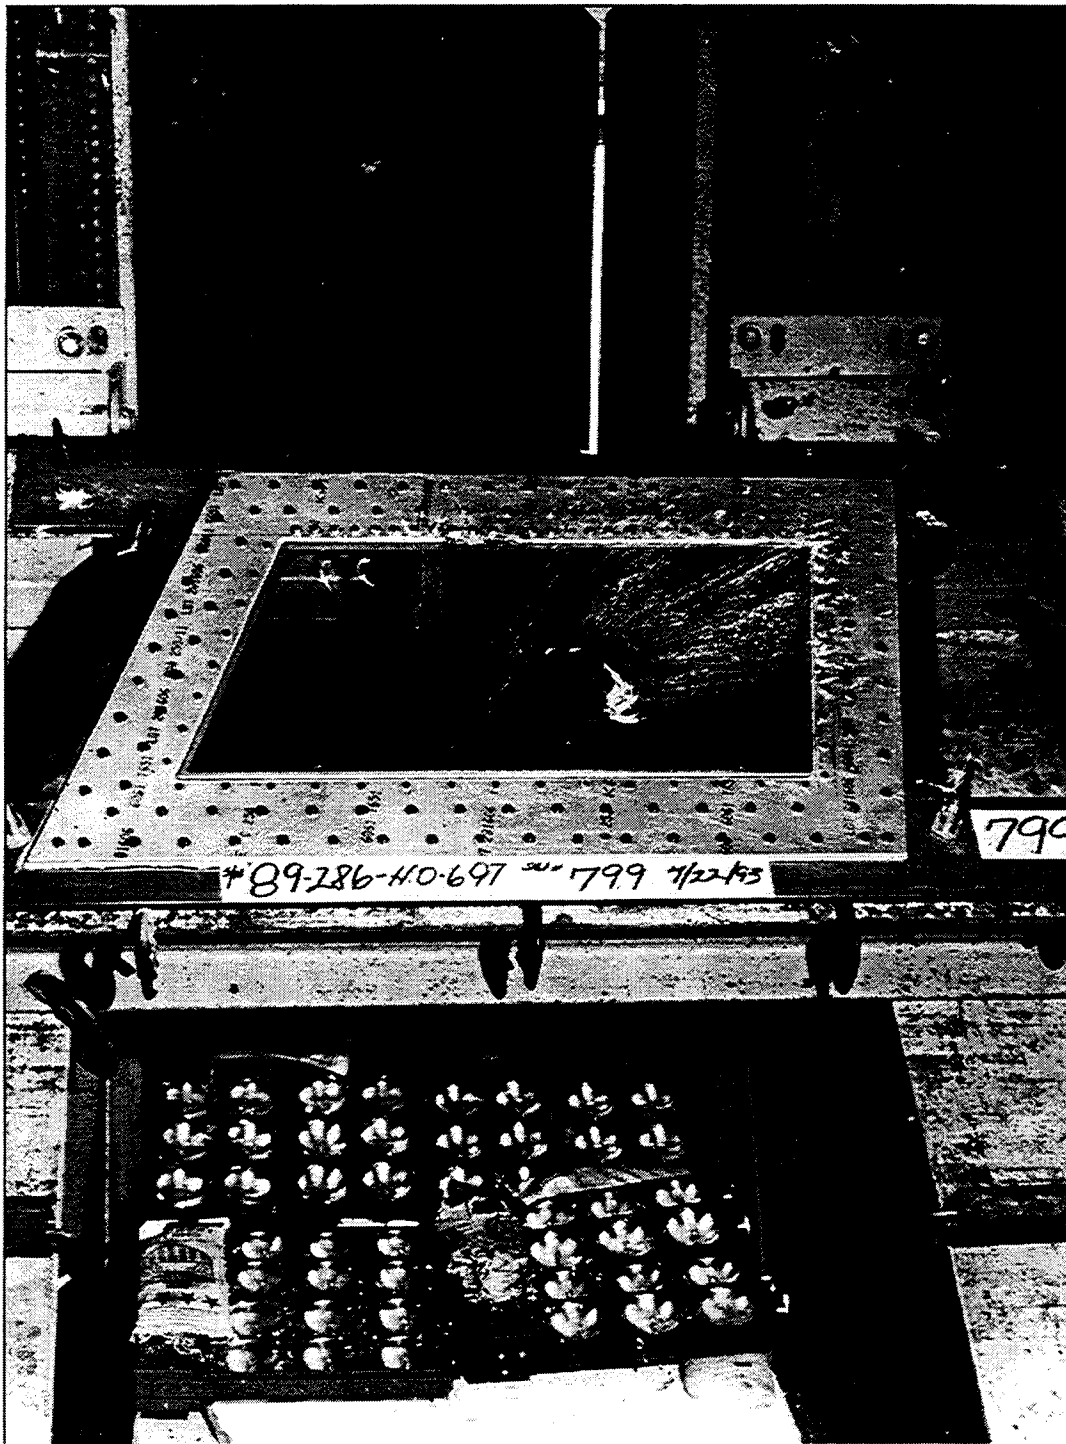
Figure 4.29 C/KC-135 #1 W/WS Showing No Damage From a 4-Pound Bird Impact at 250.8 Knots (Repaired W/WS, S/N 89-286-HO-697)

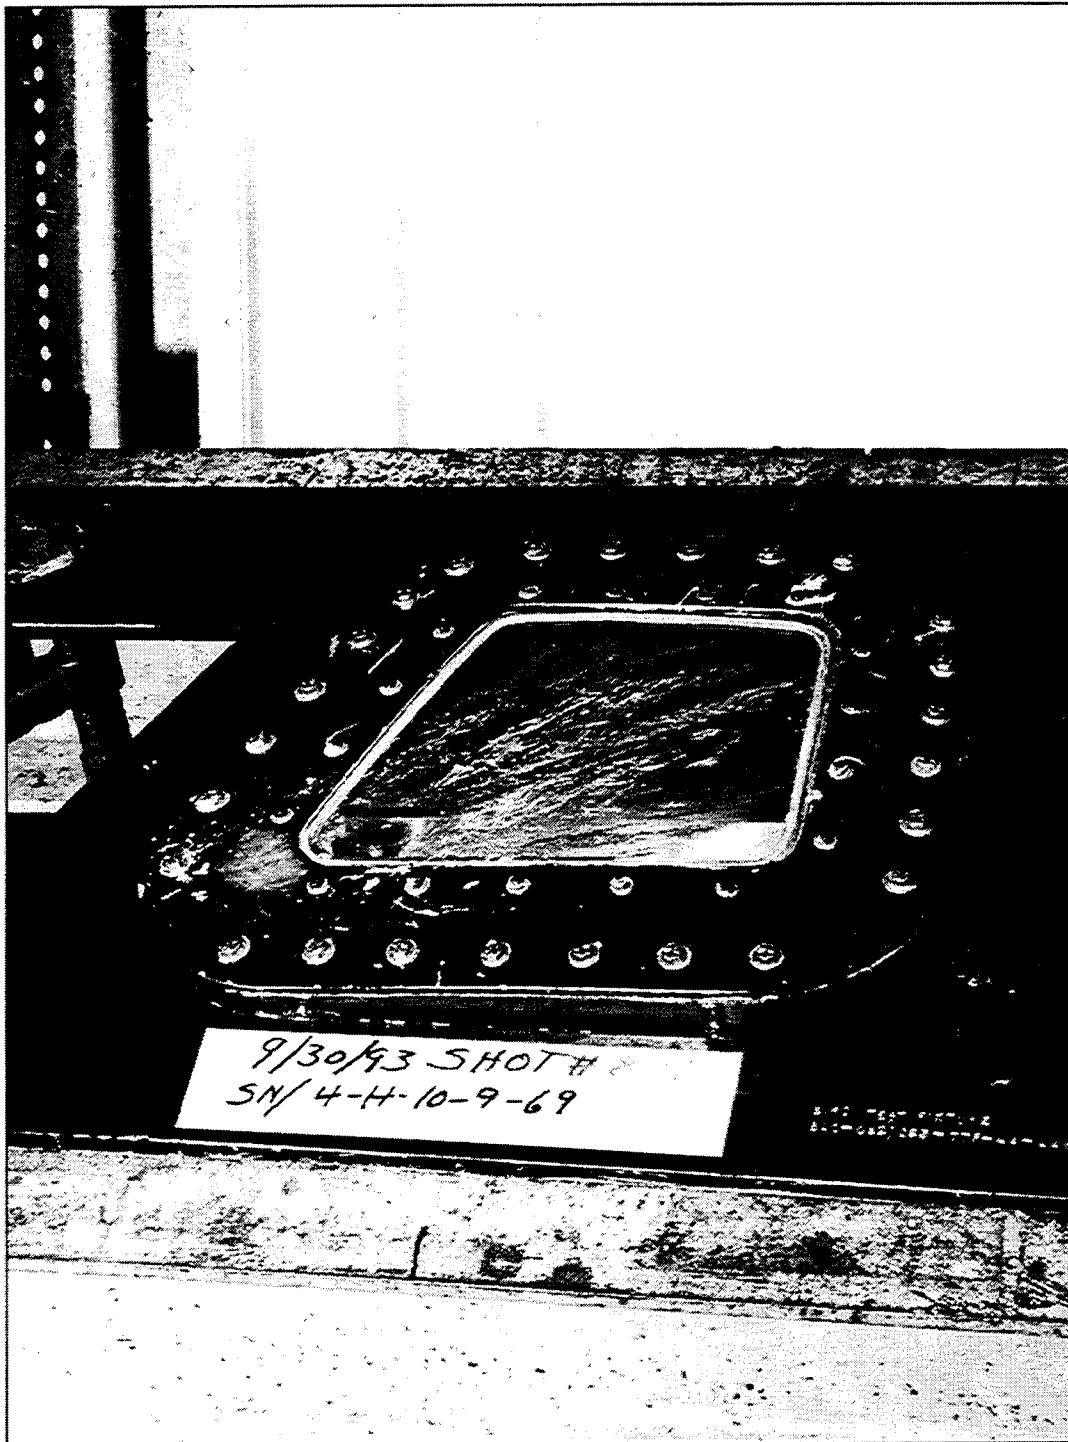
Figure 4.35 C/KC-135 #4 W/WS Showing No Damage From a 4-Pound Bird Impact at 248.7 Knots (Not Repaired W/WS, S/N 4-H-10-9-69)

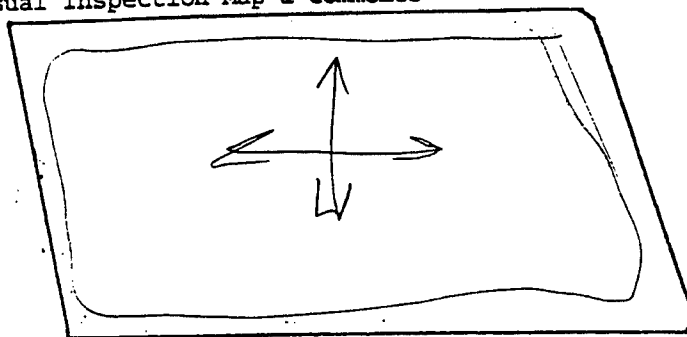
Visual Inspection Map & Comments

AIR, Delam And WATER JUST ABOUT ALL THE WAY AROUND UNIT

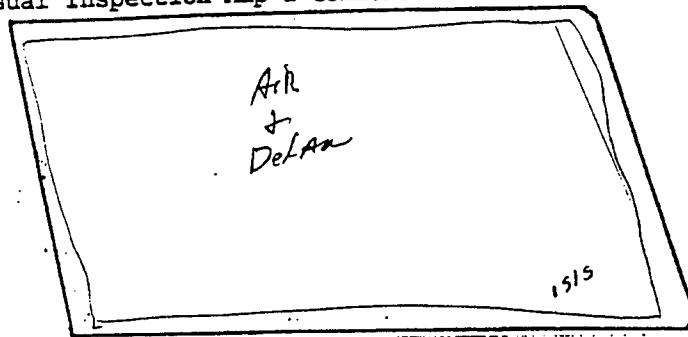
Visual Inspection Map & Comments

AIR & Delam located ALL AROUND UNIT

SURFACE SCR located BOTTOM AT Edge of Unit

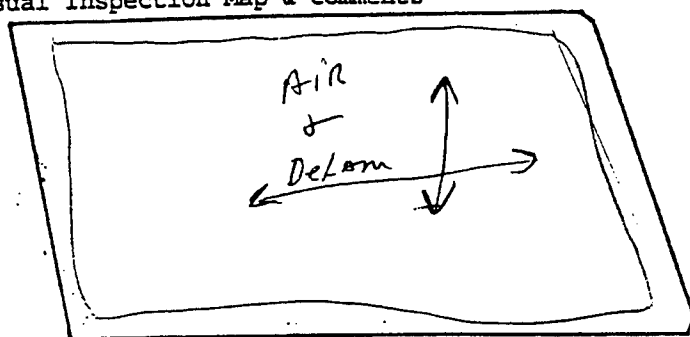
Visual Inspection Map & Comments

AIR and DeLam LOCATED ALL AROUND THE UNIT

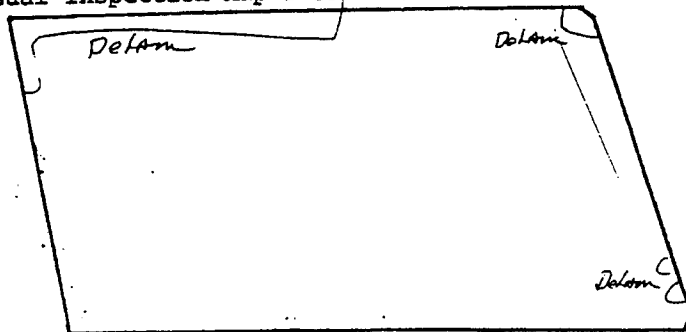
Visual Inspection Map & Comments

Delam Along TOP And Right Edge of Unit

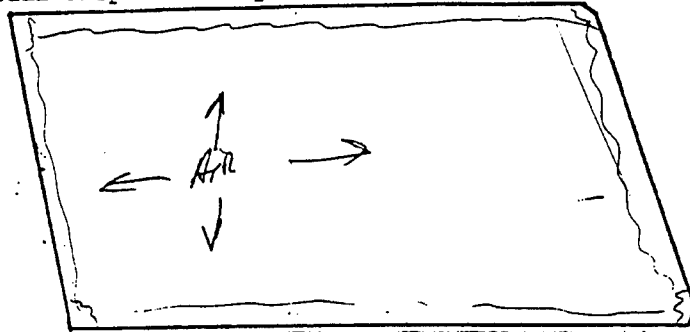
Visual Inspection Map & Comments

Air ALL Along The edge of unit.

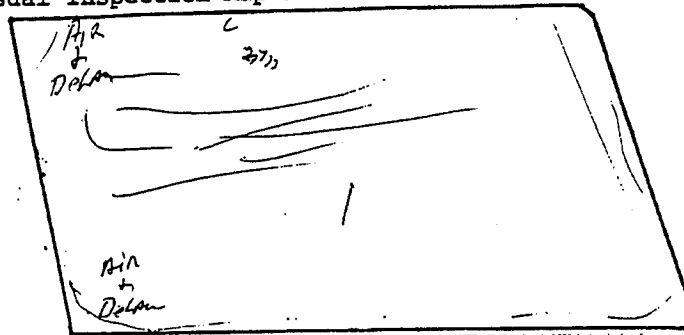
Visual Inspection Map & Comments

Air And Delam AROUND The unit.

SURFING ~~PER~~ ALL OVER The OUTER side  
of UNIT

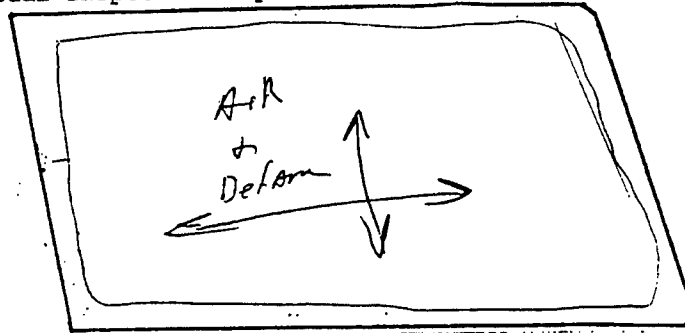
Visual Inspection Map & Comments

AIR & Deform LOCATED ALL AROUND UNIT.

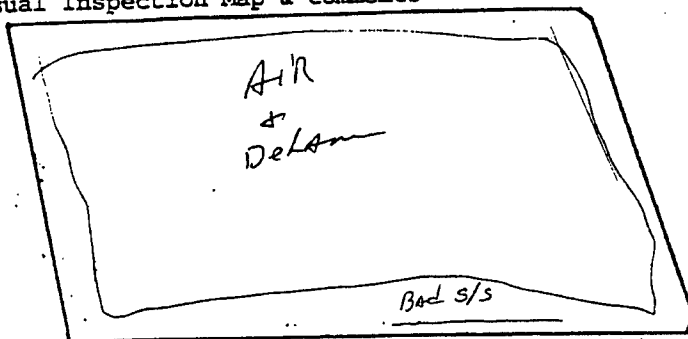
Visual Inspection Map & Comments

AIR + Delam LOCATED AROUND THE UNIT.  
VERY BAD SURFACE SCR LOCATED BOTTOM FWD. EDGE

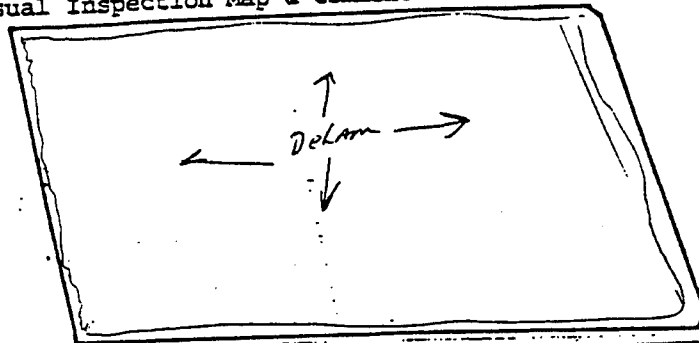
Visual Inspection Map & Comments

DeLam Located ALL AROUND the UNIT

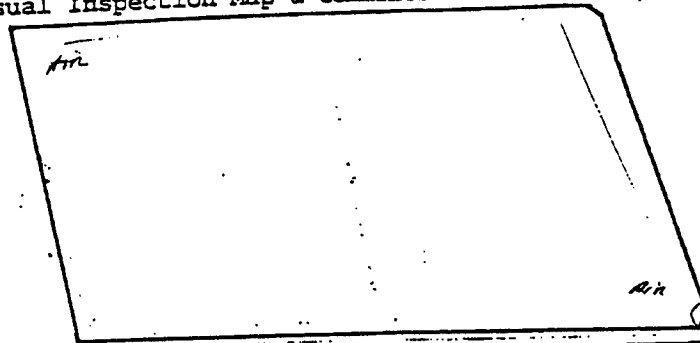
Visual Inspection Map & Comments

AIR starting above edge of unit

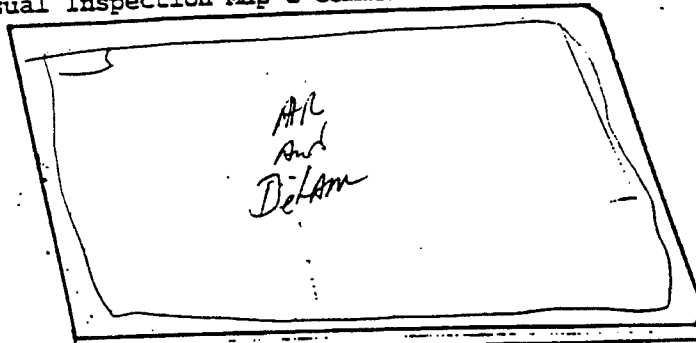
Visual Inspection Map & Comments

UNIT has AIR/DeLAM LOCATED THROUGHOUT.

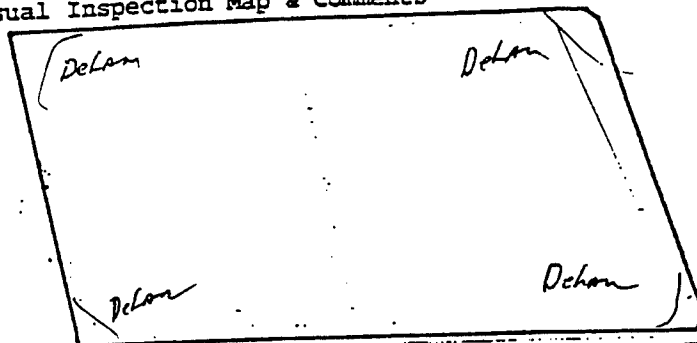
Visual Inspection Map & Comments

Delam Located in ALL FOUR CORNERS

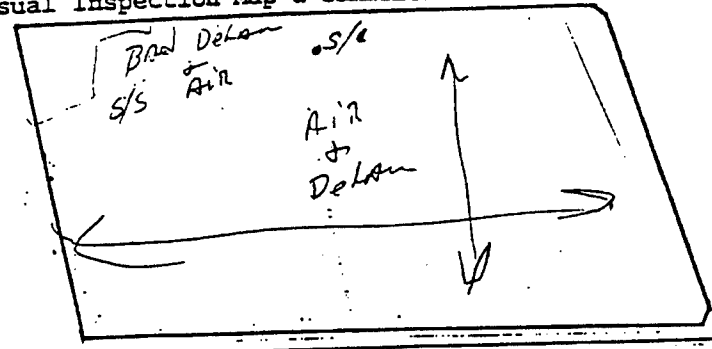
Visual Inspection Map & Comments

Air and Delam LOCATED ALL AROUND UNIT  
SURFACE SCR LOCATED AS MARKED  
SURFACE CHIP LOCATED AS MARKED

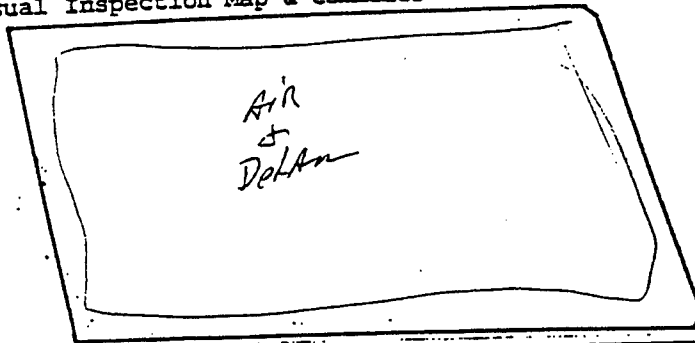
Visual Inspection Map & Comments

AIR And Delam LOCATED AROUND The Limit

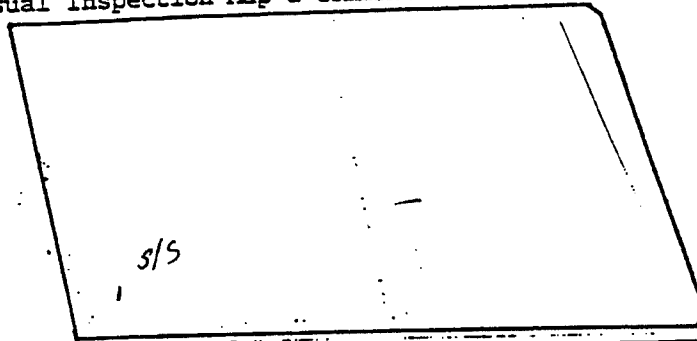
Visual Inspection Map & Comments

SURFACE SCR LOCATED AS MARKED

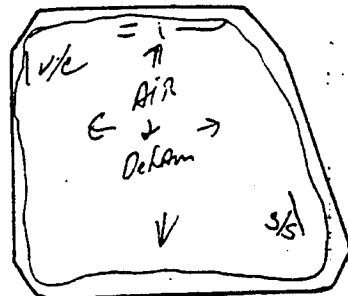
1: <u>.642</u> 2: <u>.643</u> 3: <u>.684</u> 4: <u>.686</u>			
Check for Vinyl Cracks:	<u>Rej</u>	<u>JUN 03 1993</u>	<u>22 PPG 77</u>
Seal Evaluation:	<u>Rej</u>	<u>JUN 03 1993</u>	<u>22 PPG 77</u>
(Comments)	<u>BAD Seal + Bumper on outside edge</u>		
Visual Inspection:	<u>Rej</u>	<u>JUN 03 1993</u>	<u>22 PPG 77</u>
(Place comments on attached sheet)

AIR & Deham = Located ALL AROUND UNIT  
 Vinyl CRACK located AS MARKED  
 SURFACE SCR located AS MARKED

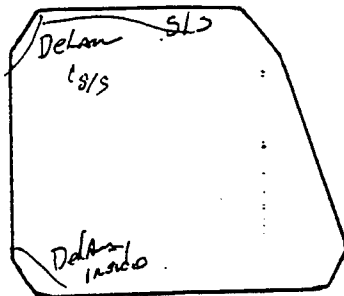
AIR And DelAm located AROUND the end  
Surface SCR. locator As marked

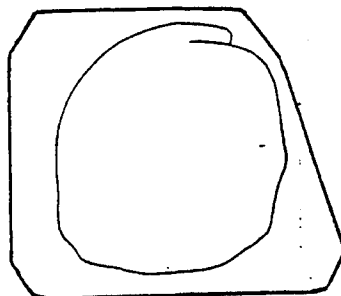
1: <u>.677</u> 2: <u>.674</u> 3: <u>.679</u> 4: <u>.676</u>			
Check for Vinyl Cracks:	<u>ReS</u>	<u>JUN 03 1993</u>	<u>22 PPG 77</u>
Seal Evaluation:	<u>ReS</u>	<u>JUN 03 1993</u>	<u>22 PPG 77</u>
(Comments) <u>no seal on bumper</u>			
Visual Inspection: (Place comments on attached sheet)	<u>ReS</u>	<u>JUN 03 1993</u>	<u>22 PPG 77</u>

Air / Delam / Viny Cracks Located All  
Around Unit

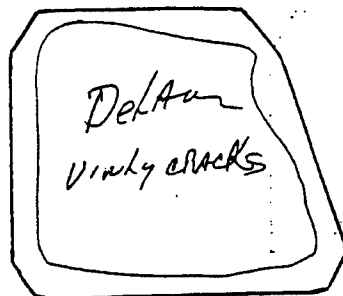
Air, Delam And Vinly cracks LOCATED ALL  
AROUND UNIT

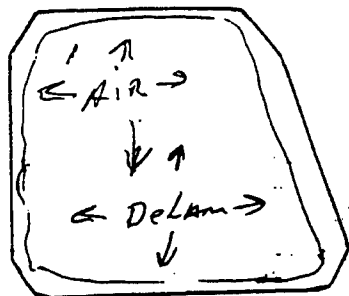
1: <u>.687</u> 2: <u>.686</u> 3: <u>.684</u> 4: <u>.685</u>			
Check for Vinyl Cracks:	<u>Rec</u>	<u>JUN 03 1993</u>	<u>22 PPG 77</u>
Seal Evaluation:	<u>Rec</u>	<u>JUN 03 1993</u>	<u>22 PPG 77</u>
(Comments) <u>NO BUMPER ON OUTSIDE</u>			
Visual Inspection: (Place comments on attached sheet)	<u>Rec</u>	<u>JUN 08 1993</u>	<u>22 PPG 77</u>

Deep S/S

B/B Res. 123.2 ~~After~~ before T.I 9/6/8 after T.I

AIR ALL AROUND of unit And ALSO DeLam

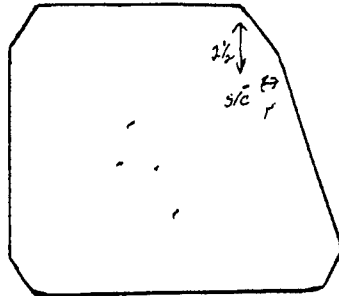
SURFACE CHIP LOCATED 2 1/2" IN DOWN AND 1" FROM FWD. EDGE  
AND OTHER SURFACE DEFECTS LOCATED CENTER OF UNIT

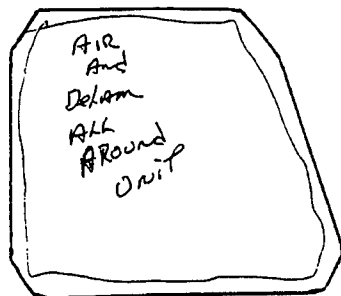
AIR And Delam located ALL Around Unit

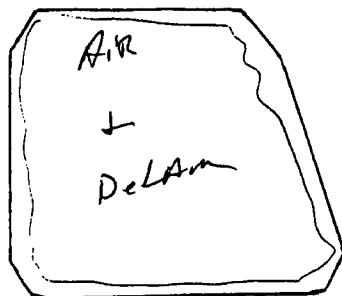
1: <u>.689</u> 2: <u>.701</u> 3: <u>.697</u> 4: <u>.687</u>			
Check for Vinyl Cracks:	<u>Acc</u>	<u>JUN 03 1993</u>	<u>22 PPG 77</u>
Seal Evaluation:	<u>ReS</u>	<u>JUN 03 1993</u>	<u>22 PPG 77</u>
(Comments)	<u>BAD Buffing at window seal on out side</u>		
Visual Inspection:	<u>ReS</u>	<u>JUN 03 1993</u>	<u>22 PPG 77</u>
(Place comments on attached sheet)

AIR And DeLAM is located ALL Around  
Unit.

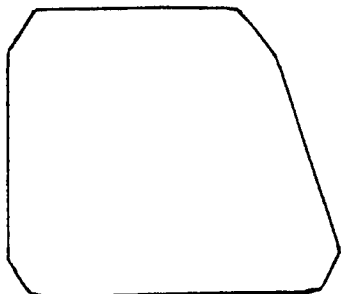
Visual Inspection Map & Comments

1: <u>5</u> 2: <u>5</u> 3: <u>5</u> 4: <u>7</u>			
Dimensional Inspection:			
Unit Thickness: (Per Template)	<u>Acc</u>	<u>5-25-93</u>	<u>22 PPG 28</u>
1: <u>.688</u> 2: <u>.685</u> 3: <u>.691</u> 4: <u>.691</u>			
Check for Vinyl Cracks:	<u>Acc</u>	<u>JUN 02 1993</u>	<u>22 PPG 77</u>
Seal Evaluation:	<u>Acc</u>	<u>JUN 02 1993</u>	<u>PPG 77</u>
(Comments)	_____		
	_____		
	_____		
Visual Inspection:	<u>Acc</u>	<u>JUN 02 1993</u>	<u>22 PPG 77</u>
(Place comments on attached sheet)

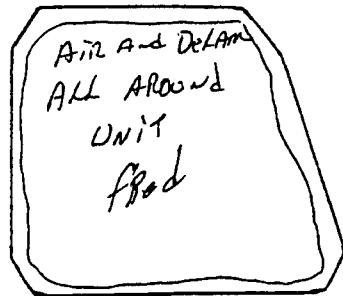
Visual Inspection Map & Comments

1: <u>.684</u> 2: <u>.679</u> 3: <u>.685</u> 4: <u>.679</u>			
Check for Vinyl Cracks:	<u>Acc</u>	<u>JUN 03 1993</u>	<u>22 PPG 77</u>
Seal Evaluation:	<u>ReS</u>	<u>JUN 03 1993</u>	<u>22 PPG 77</u>
(Comments) <u>WRONG Seal on OUTlet side</u>			
Visual Inspection: (Place comments on attached sheet)	<u>ReS</u>	<u>JUN 03 1993</u>	<u>22 PPG 77</u>

Air And Delam ALL AROUND Edge of Unit

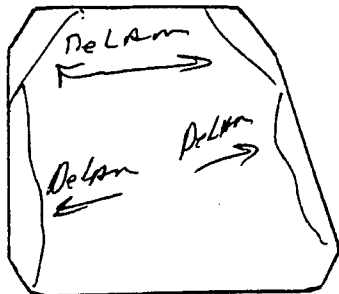
Visual Inspection Map & Comments

De Lam And Air ALL AROUND ~~it~~

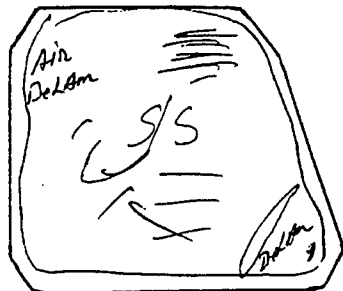
Visual Inspection Map & Comments

Seal Evaluation:	<u>ReJ</u>	<u>JUN 03 1993</u>	<u>22 PPG 77</u>
(Comments) <u>BAD SEAL AND BUMPER</u>			
Visual Inspection: (Place comments on attached sheet)	<u>ReJ</u>	<u>JUN 03 1993</u>	<u>22 PPG 77</u>

BAD SURFACE SCR LOCATED THROUGHOUT THE UNIT  
BOTH SIDE

AIR AND DeLAM LOCATED ALL AROUND UNIT

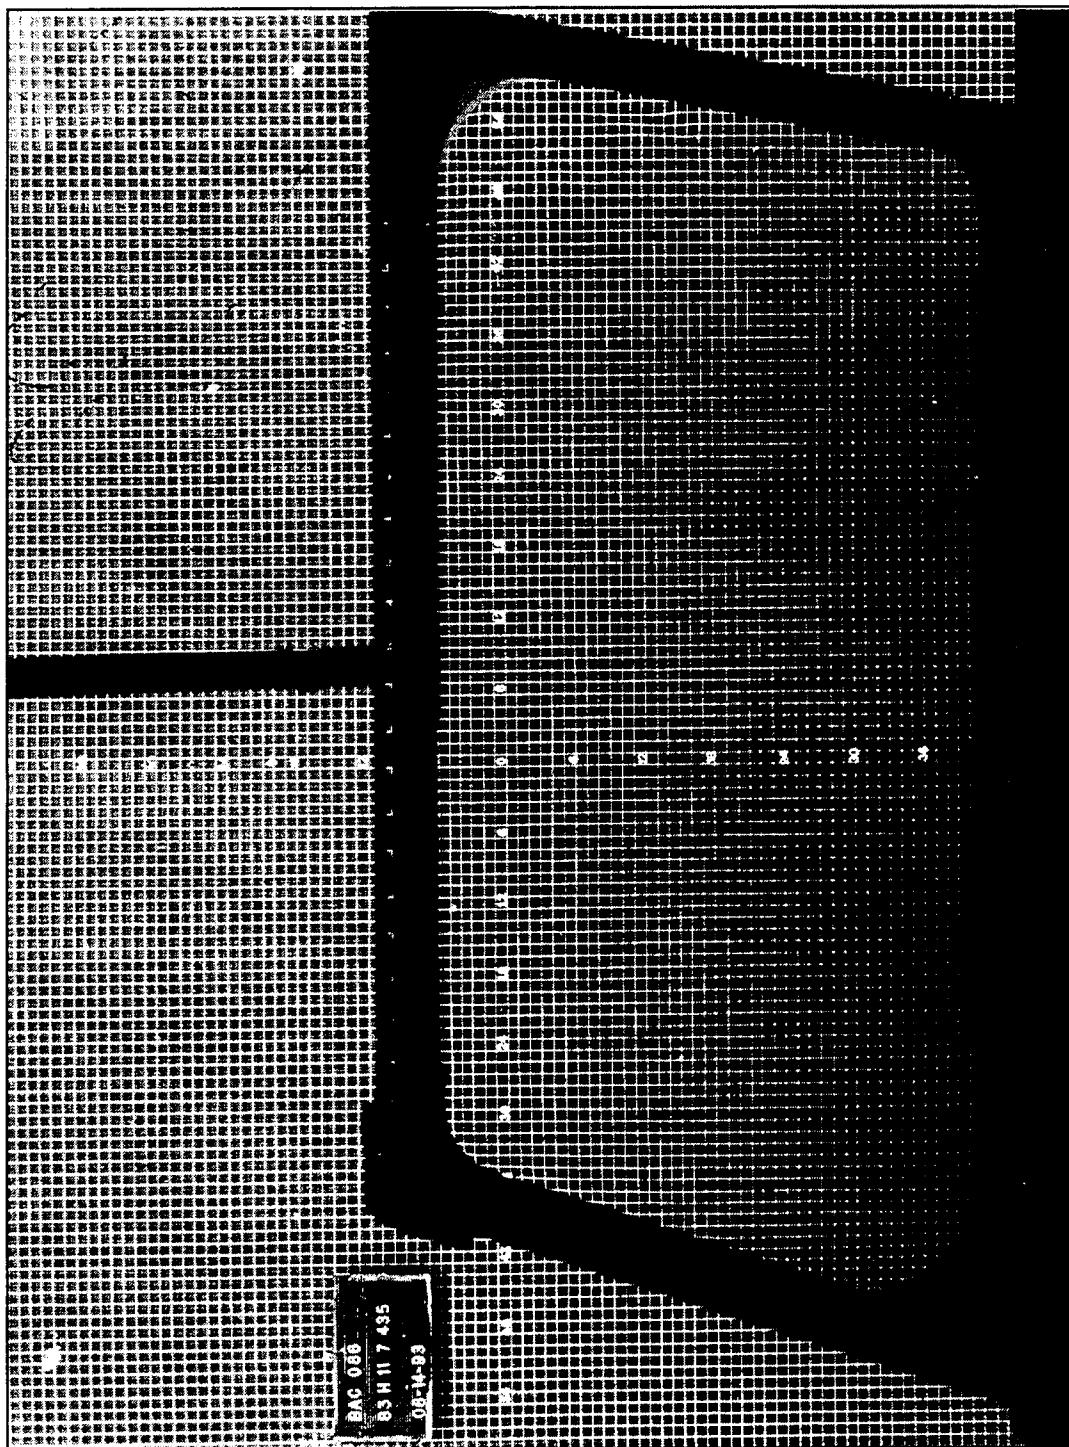
Figure 4.3 Worst Optical Distortion Found in Any C/KC-135 #1 W/WS (S/N 83-H-11-7-432)

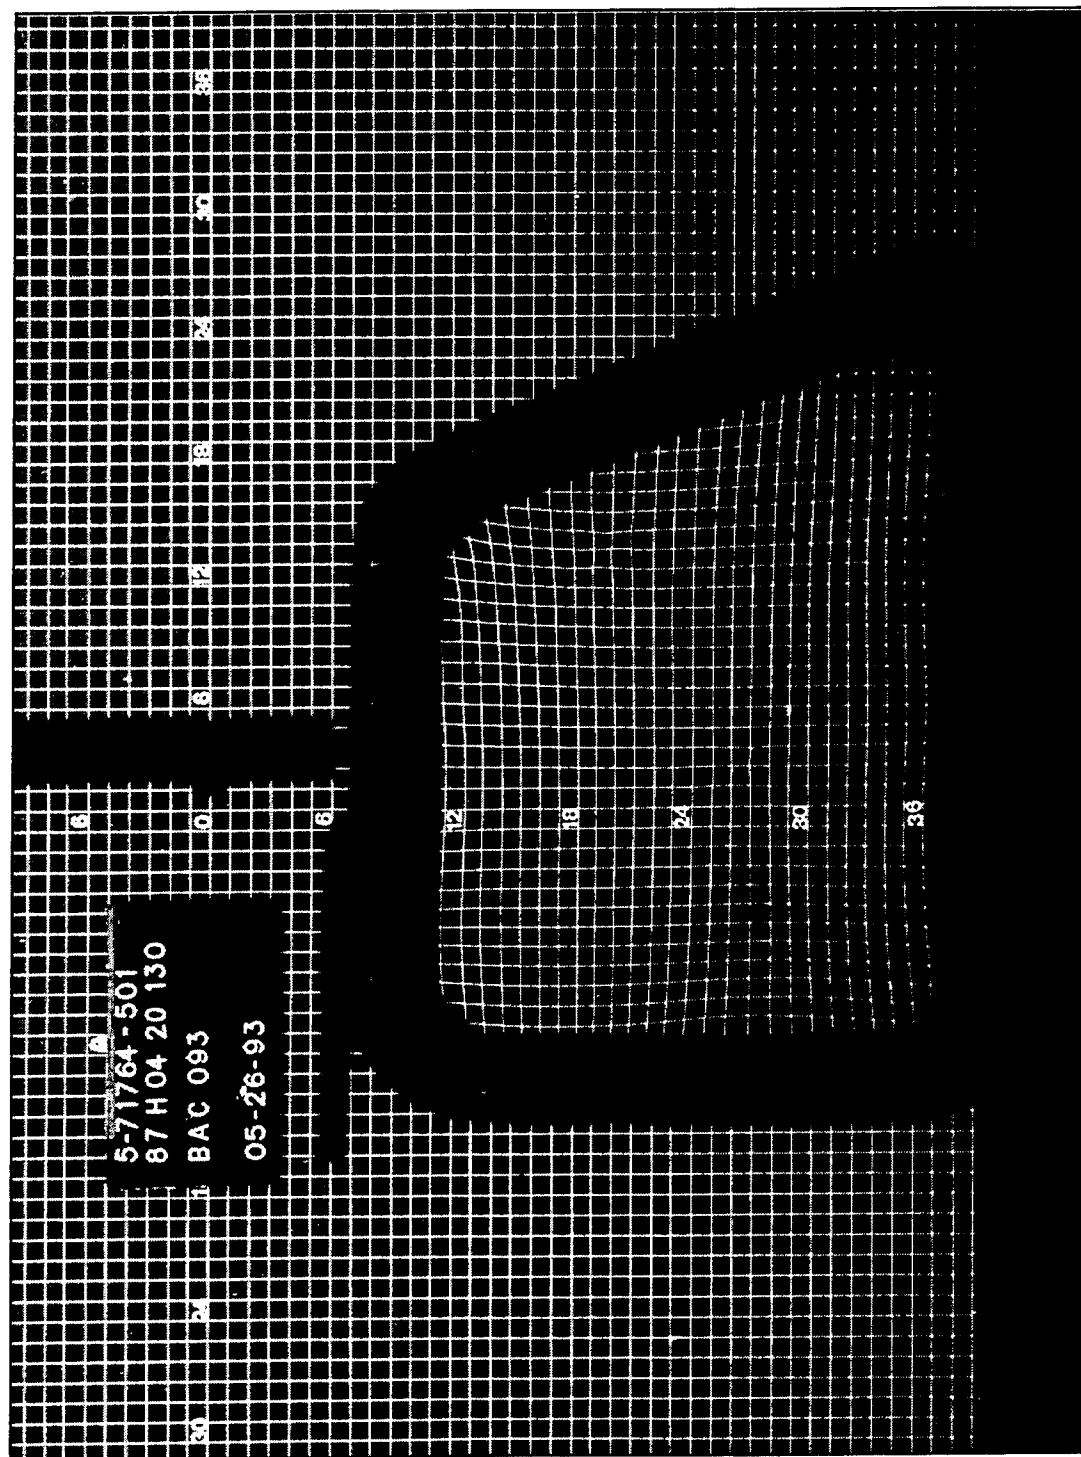
Figure 4.4 Worst Optical Distortion Found in Any C/KC-135 #4 W/WS (S/N 87-H-04-20-130)

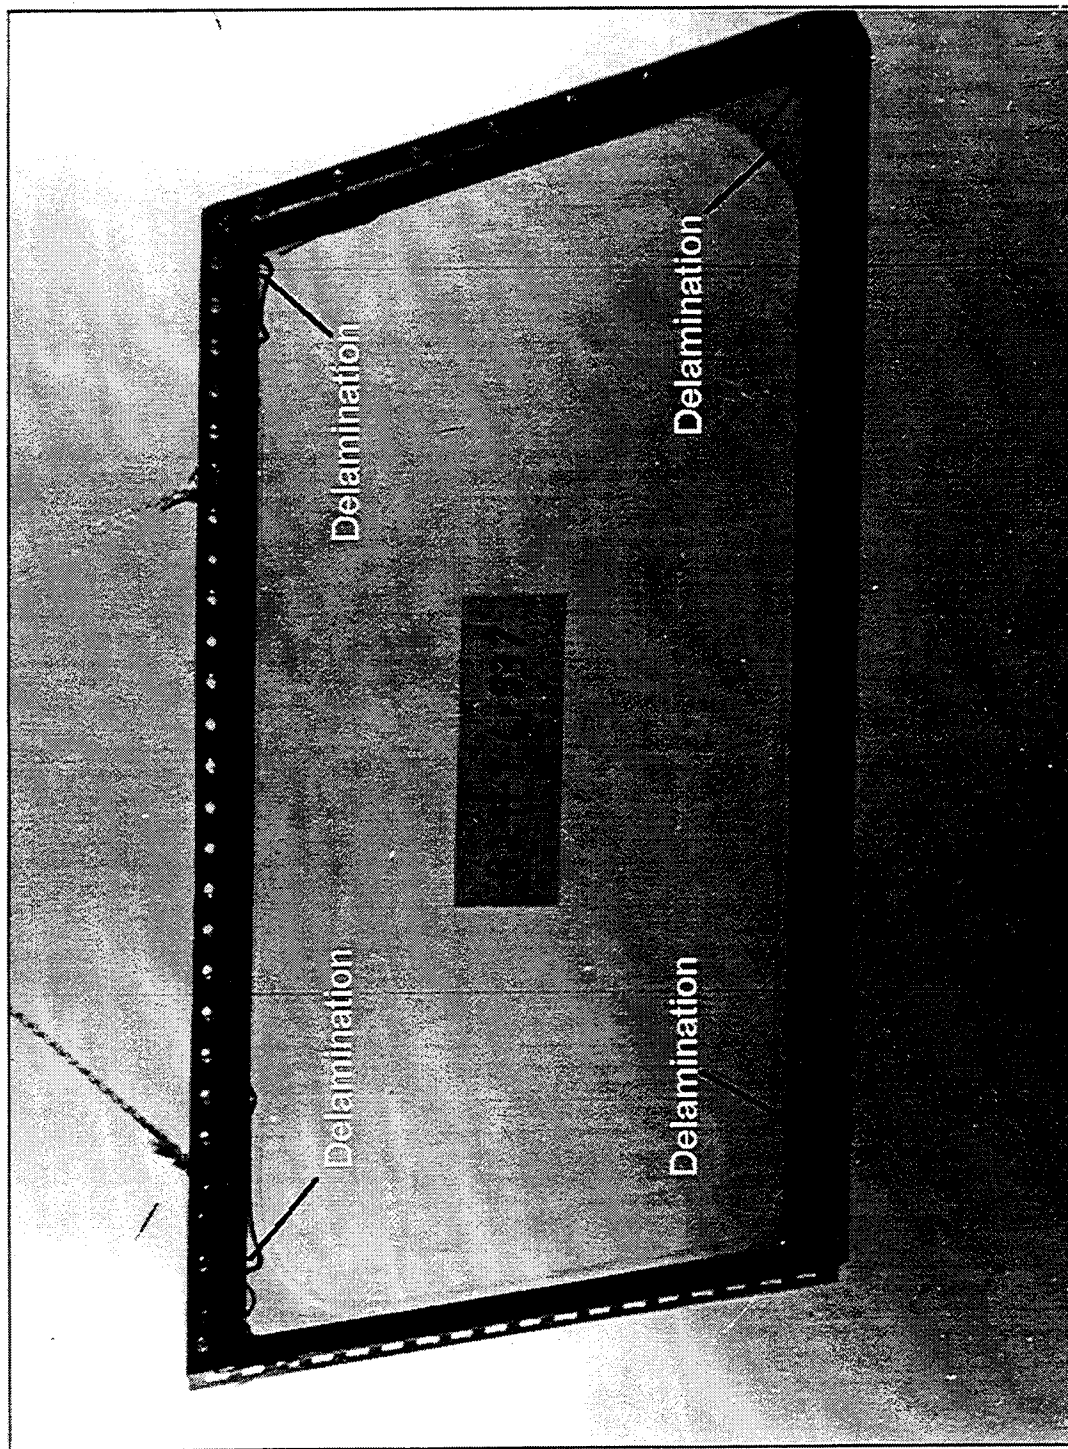
The results of the pressure integrity testing are presented in Tables 4.9 and 4.10. None of the W/WS, repaired, not repaired, or new, exhibited any catastrophic failures. Two of the repaired W/WS did experience delaminations, while no evidence of delamination was detected in the new W/WS. Figure 4.11 shows the worst delamination observed in a #1 W/WS. Figure 4.12 shows the worst delamination observed in a #4 W/WS. In these figures, the edge of the delamination has been outlined with a black marker. The delamination in the #1 W/WS would not interfere with pilot vision, and may not even be noticed. The delamination in the #4 W/WS, would, most likely, be noticed and reported by a pilot.

Figure 4.11 Worst Delamination Observed in a C/KC-135 #1 W/WS From Pressure Cycling (Repaired W/WS, S/N 82-H-09-06-537)

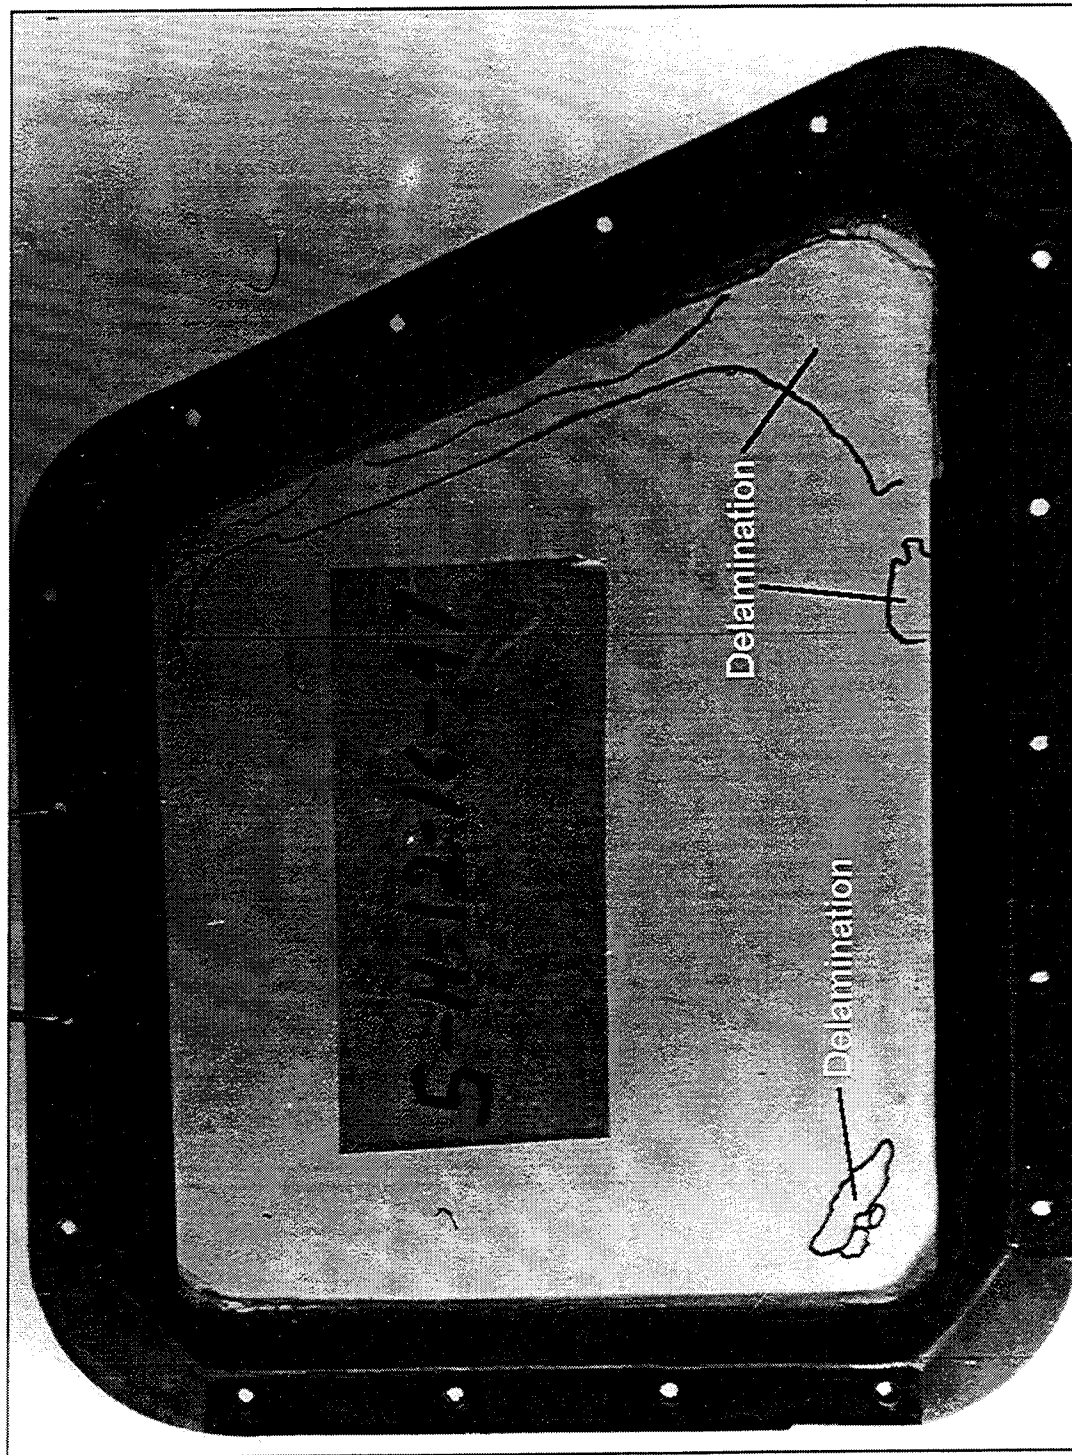
Figure 4.12 Worst Delamination Observed in a C/KC-135 #4 W/WS From Pressure Cycling (Repaired W/WS, S/N 5-H-12-16-47)
